SURVEY OF MICROSTRUCTURES AND MECHANICAL PROPERTIES OF

OVER-TEMPERATURED S-816 TURBINE BUCKETS

FROM J47 ENGINES

March 20, 1957

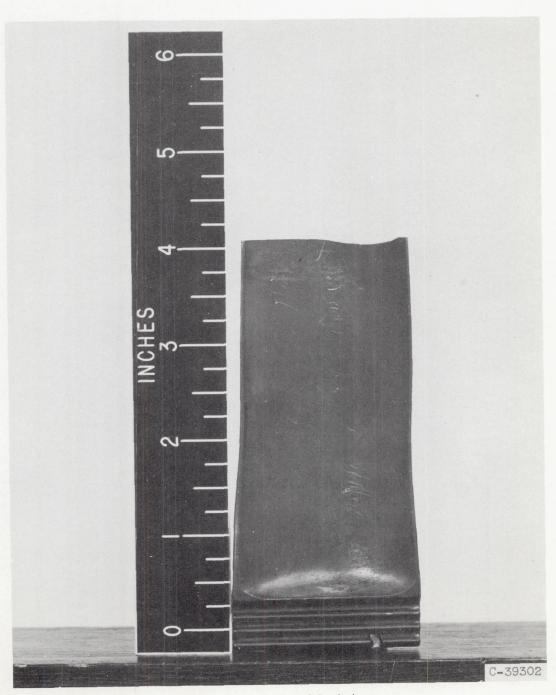
Figure 1. - Necked bucket.

Four of the buckets of unspecified overtemperature history were necked. A photograph showing an example of this necking is presented in figure 1. The necked buckets were 5, 6, 13, and 14 (table I).

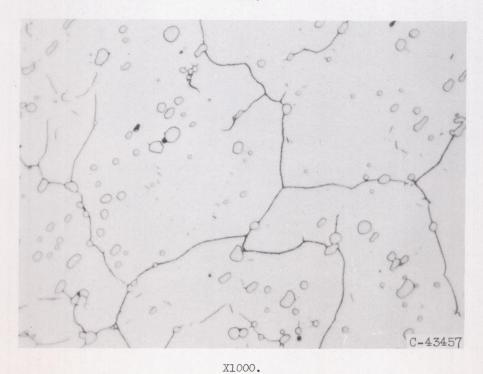
(a) Normal. Reduced 6 percent in printing.

The microstructure of heat-treated S-816 is presented in figure 4(a). Aside from the residual columbium-tantalum-type carbides, the carbides that precipitate in aging are very fine. When subjected to increasingly higher temperatures, these fine carbides tend to coalesce and spheroidize, producing what is termed an overaged microstructure as illustrated in figure 4(b). At still higher temperatures, these carbides tend to redissolve into the matrix until the alloy becomes predominantly a solid solution with the exception of the very stable columbium-tantalum carbide precipitate.
